# Documentation of Yorùbá Traditional Institutional Building: The Case of Àfin Irefin

*Àfin Irefin* is located in the core of Ibadan a *Yorùbá* city and capital of Oyo State. Constructed in 1910 as the institutional building and residence of *Bale Ogundeji Irefin*. Ogundeji Irefin was the 23rd Bale (Oba) of Ibadan. The family till date hold an historical significance of being the descendants of *Oba Onirefin* who built the biggest palace in the history of Ibadan during his reign between 1912 to 1914. The palace portrays the *Yorùbá* architecture in its originality. The city of Ibadan is known for its historical landmarks of both traditional and *Yorùbá* townhouse architecture among which *Àfin Irefin* happens to be the only traditional institutional building till date. The documentation of this structure will not only serve as record for restoration and conservation purposes, but contributes to the literature on Yoruba palaces. Though Ojo covered *Yorùbá* palaces of *Ife*, *Abeokuta*, *Ijebu-Ode*, *Oyo Owo* and *Ado Ekiti*, *Àfin Irefin* is a continuation of data collection on *Yorùbá* palaces [19]. The paper will further contribute to the preservation of the historical architectu

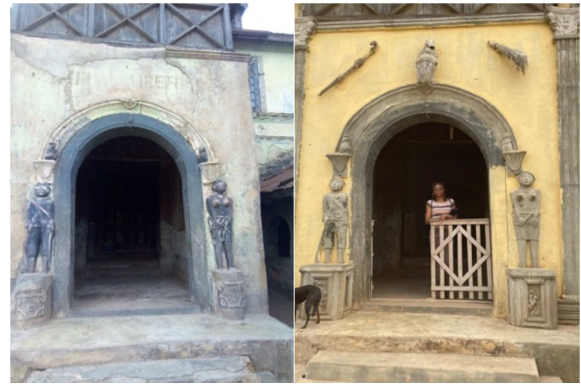
**Figure 5.** Showing Entrance into the main residence of Oba Irefin in 2009 and 2021.

It is observed that in the space of 12 years, modifications have been made on the decorative moldings and introduction of more decorative elements especially at the entrance to the main residence of the residential quarter of the *oba* (Figure 5). There has also been some intervention in some parts of the palace (Figure 3) which defiled the use of original or replica of the materials initially used for construction. The present condition of the *Àfin Ireḡin* shows deterioration and collapse in some parts (Figures 7 and 8). However, the nature and types of the materials used can still be ascertained and thus

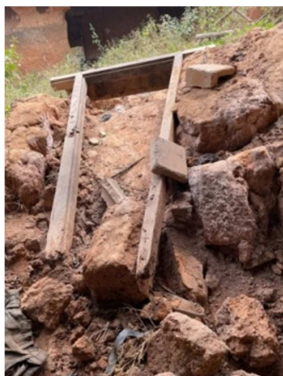
**Figure 8.** Showing extent of dilapidation in the Ka Esin (Courtyard to stable for horses).

On entry to the palace (Figure 3) is the entrance court bounded by the four sides. The courtyard serves as a public space and place for festivals, religious ceremonies as well as political and socio-cultural activities. Directly facing the public courtyard is the only story building in the palace compound (figure 4). The story building which is the focal point of the palace is the personal residence of *oba Irefin* and flanked by residential quarters to the left and right side. The ceremonial courtyard is bounded on two side by residential quarters for male children popularly known as boys' quarters. The ceremonial courtyard serves as a space for religious and cultural ceremonies. On the entrance side, the courtyard is bounded by the 5 gable porch which is part of the boundary fence. The residential structures of semidetached bungalows are opened to 2 other courtyards (Figure 6) linked by verandas and common corridors. This residential area served as the private apartments of the king's wives; princesses, retainers and slaves. Behind the royal quarter (Figure 7) links the king's court (*Igbejo*) opened to a courtyard that leads to the stable for horses (*ka esin*). Both the king's court and the horse stable are in deplorable state as all the earthen walls have collapsed due to lack of continuous maintenance as well as effect of weather (Figure 8).

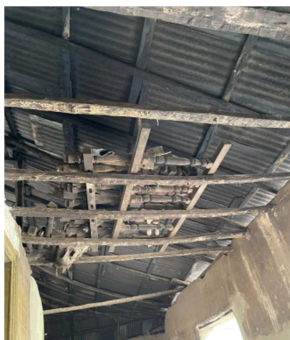
**Figure 9.** Showing carved hard wood balustrade stored since 1912 in the Aja.

Wood was used for interior and exterior finishes of the royal quarter. This is also indicated on the exterior through the jalousie used as shutters and exterior walls of the upper balcony of the story building (Figure 4). Wood was also used as a structural element for the first floor of the story structure. Long hardwood boards served as structural floor and floor finish of the king's residence. Sun screens over internal window opening was employed to keep sunrays at bay within the private residence. Internal partitioning as depicted in Figure 12 and two staircases within the story building were also of wooden material. Thus, highlighting the use and importance of wood in construction by the *Yorùbá* people. Wood also provided privacy and shade from sunrays and left bare as interior cladding for door openings and wall covering to present a space befitting royalty of that era and culture. (Figure 11). Thick wooden balustrades adds to the interior aesthetic for the palace since it was constructed in 1912. Some fabricated balustrades yet to be fitted are stored within the ceiling of the residential quarters (Figure 9).

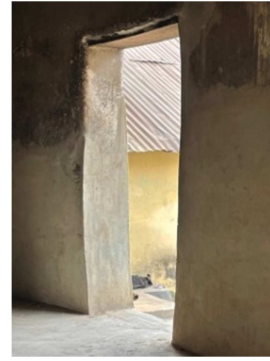
**Figure 10.** Showing wall thickness, wooden lintel support.

Construction was carried out using *pise* for the walls and finished with fine earthen material that was later plastered with cement screed. Rammed earth construction technique was employed in the construction of the palace. Each course of well mixed earth is compacted and allowed to dry before another layer was added (Figure 7). Load bearing walls of 300mm thick was utilized in the construction of the bungalow structure while 450mm thickness was used in the story building.

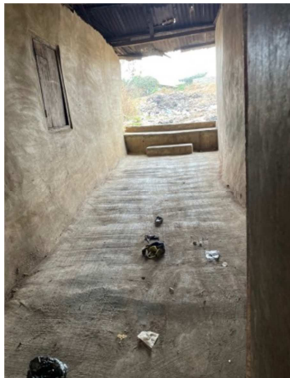
**Figure 19.** Showing the pathway to the back of the palace now being used as a dump site.

accessible by intruders through the dilapidated section at the rear of the palace and the corridor that leads to the dump site (Figure 19).

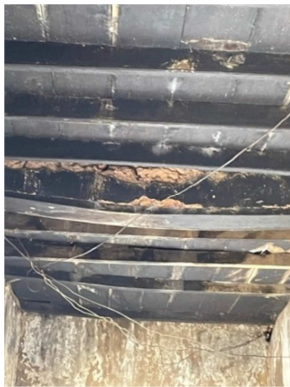
**Figure 20.** Showing failing first floor support in need of restorative intervention.

The elaborate wooden finishes on the archways [14, 15] are still in good condition and will benefit from periodic maintenance to allow them last another decade. Wooden floor board are utilized on the upper floors of the *àfin Ireḡin* and some of these wooden elements like the handrails are still in good condition. However, a section of the floorboard is about to give way due to the load from the earthen wall on the first floor (Figure 20). This section of the *Oba's* quarters is in need of immediate structural attention and intervention.
